Improvement Incoloy Alloy 800 Weldability After 10 Years of Service through Solution Annealing and Normalizing Method

Amir Arifin, Gunawan*, Jaya Rizki Saputra

Department of Mechanical Engineering, Sriwijaya University, 30662 Indralaya, Sumatera Selatan, Indonesia.

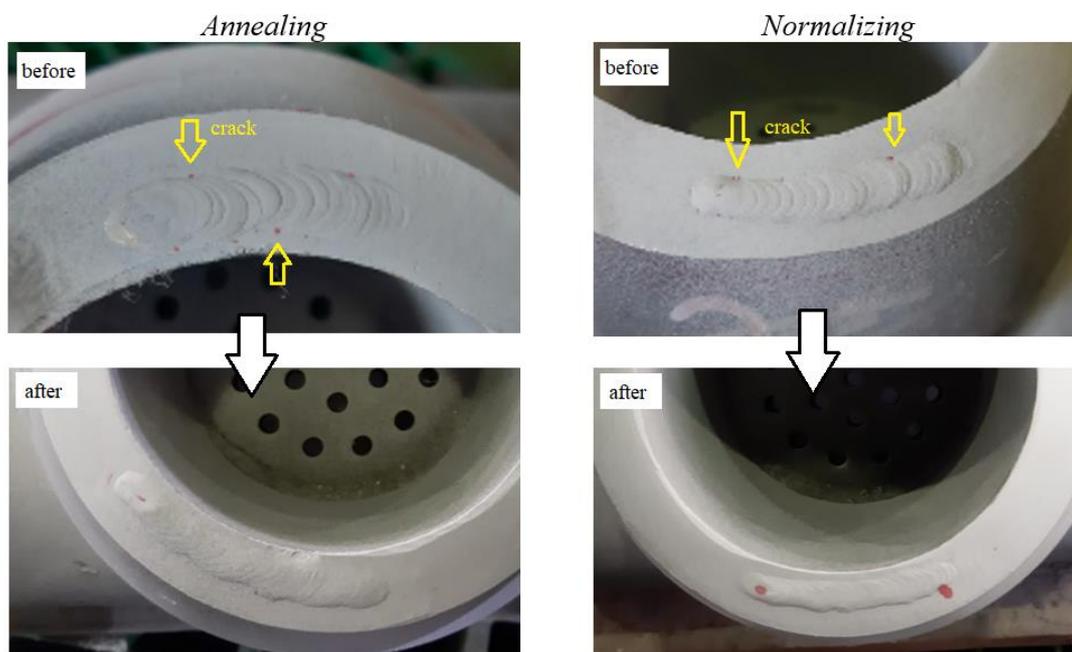
Figure 3. Weldability test before and after heat treatment

treatment process stated that the normalizing sample indicated that there were still indications of defects or cracks on the surface of the normalizing sample that the welding process had carried out. The indication of defects or cracks in normalizing samples has been significantly reduced, as shown in Figure 3. Defects or cracks can be seen from the results of the penetrant test, which resulted in a red penetrant liquid after the developer fluid spraying process. Weldability test revealed that sample annealing solution showed no indication of defects or cracks after the welding process was carried out on the sample surface.

Heat treatment of samples was carried out by solution annealing and normalizing methods that have the main objective of reducing residual stresses to improve the ductility of the alloy 800. Parameters in heat treatment refer to ASME Section VIII Div 1 part UCS-56 and UNF-56.

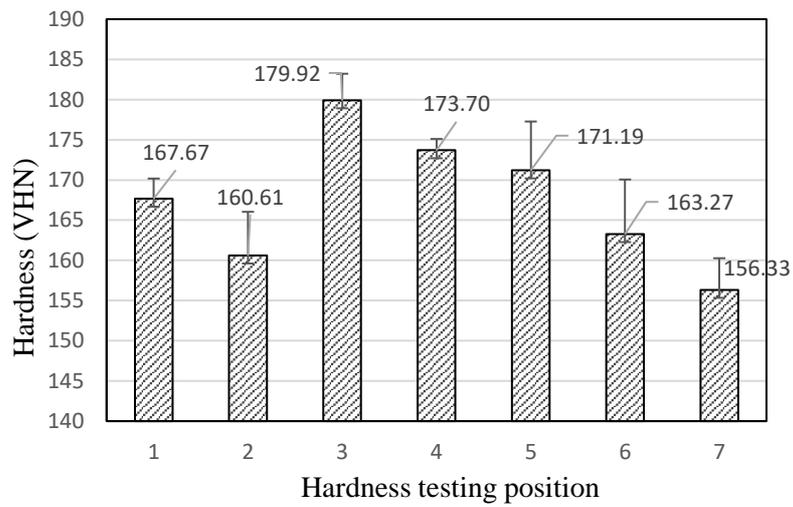
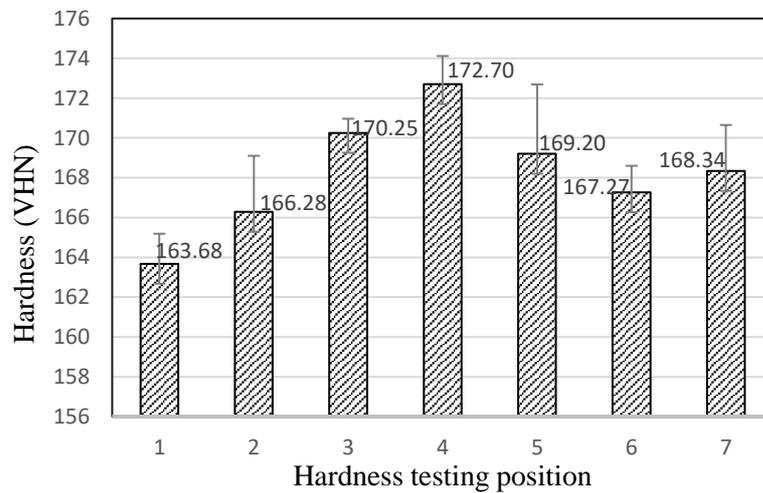
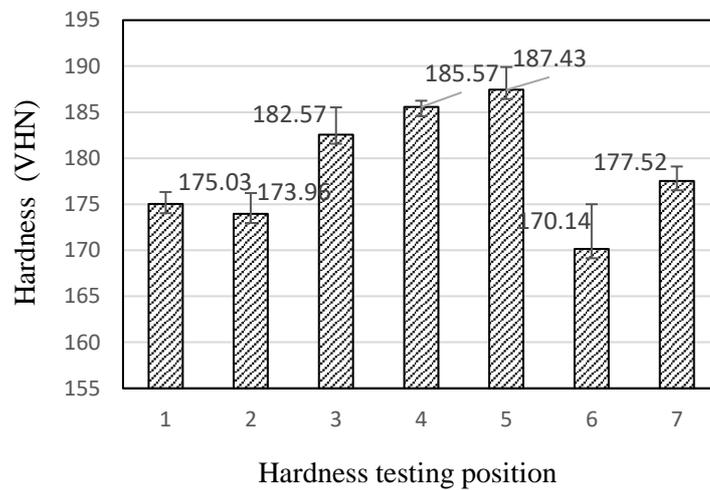
Figure 5. Hardness profile on weld zone (a) Nontreatment, (b) Solution annealing, and (c) Normalizing

The hardness test results shown in Figure 5 states that the base metal represented by zone 1,2,6 and 7 has decreased hardness from the technical data standard of the alloy 800. The material standard technical data shows the hardness value of the superalloy material with the main element made from nickel and chromium are 170 VHN, while the highest hardness in the base metal is 167 VHN. The low hardness value on the non-treated samples is due to the prolonged exposure to heat during the operation process, as shown in Figure 5 (a). a decrease in the hardness value results in a failure phenomenon such as creep. The hardness value increases in the fusion zone (3,4, and 5) due to new alloys from the filler rod, as shown in Figure 5 (b).

The normalizing sample was machined and polished for preparing the hardness sample test. Furthermore, Hardness testing was carried out seven times at different zone with three repetitions, as shown in Figure 4. Figure 5 (c) shows the hardness testing results on normalizing samples. The test results show that the hardness value of the base metal is close to the Incoloy alloy 800 standard hardness value. The base metal hardness value increased after normalizing treatment if compared to solution annealing and non-treated samples. Due to the slower cooling rate impact, the greatest hardness value on the base metal was reached at 177 VHN during the normalizing process. The preservation of carbide throughout the heat treatment procedure with a slow cooling rate is significant in the resultant growth (Aloraier,

The maximum hardness value is 187 VHN in zone 5 on the welding zone. Several variables, such as carbide precipitation and additional alloying elements, influence the hardness value to be high in the welding area. Figure 6 (a) shows the XRD test results from nontreatment samples. The phase characteristics of the alloy material 800, which has been operating for a relatively long time, consist of phases of austenite, Cr_{23}C_6 , and NbC. The main peaks show the austenite phase with an angle value of 2θ of 43.582 and a peak intensity of 768. An angle value of 2θ of 50.1 indicates the second-highest peak phase with a peak intensity of 368 diffusions (Arifin, Gunawan, et al., 2020). The lowest peak is the diffusion of niobium and carbon, forming NbC carbides with an angle of 2θ of 74.2 and a peak intensity of 90.

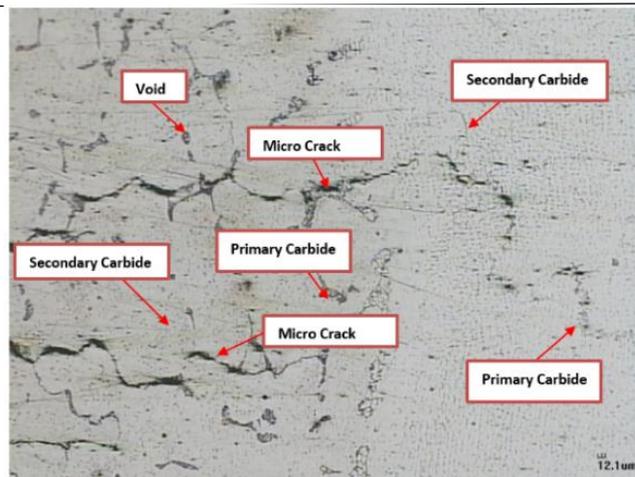
Figure 7. Metallographic testing results of nontreatment sample

The observation result of the nontreatment sample is shown in Figure 7. the microcrack attacks the grain boundaries because there are voids that have fused and are connected. The voids have been spread out in grain boundaries to around grains. Voids can coalesce and be connected due to the influence of residual stress from thermal activity. The microcrack will cause creep cracking on the surface, which causes cracking in the aging Incoloy alloy 800. According to the standard of Manoir Industries, the appearance of microcracks following the weldability test method indicates that the performance of the material has deteriorated. (Anderoglu 2004).

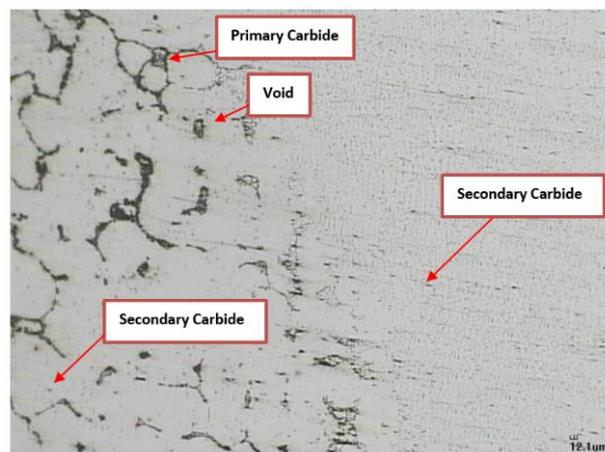
Figure 8. Metallographic testing results of solution annealing sample

The annealing solution sample shown in Figure 8 revealed no microcracks like the non-treated sample. The sample annealing solution indicates the presence of primary carbide, secondary carbide, and voids, but microcrack does not occur in the annealing solution sample. The absence of microcrack is caused by a reduction in residual stress, which minimizes the

formation of connected and unified voids.

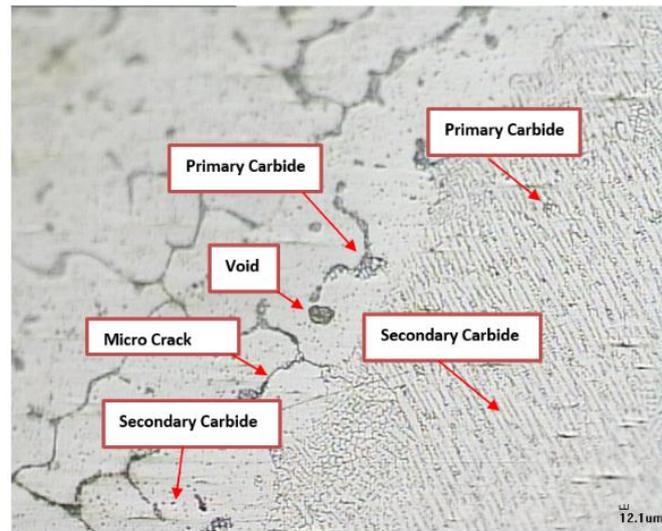
Figure 9. Metallographic testing results of normalizing sample

The normalizing sample is shown in Figure 9 states that there are microcracks that have spread to the boundaries of the weld area. Micro crack propagation occurs due to the influence of heat on the weldability test process. The reduction in residual stress also occurred in the normalizing samples, which was shown in the microcrack formation results that were not as large as the nontreatment samples. The heat treatment minimizes residual stress that can affect voids so that voids do not coalesce and coalesce to form a microcrack.
