# Metallurgical investigation of failed superheater tube used in thermal biomass power plant

Jutaporn Chaichalerm\*, Chaiyawat Peeratatsuwan\*\* and Thee Chowwanonthapunya\*\*\*

This article presents an investigation of a failed superheater tube made of SA210 Grade C used in a biomass power plant. Visual inspection, microstructural examinations, chemical analysis, and hardness measurements were conducted to analyze the causes of the superheater tube failure. The results showed that the failure was mainly caused by long-term overheating, resulting in excessive thermal oxidation and graphitization. Excessive thermal degradation accelerated reduction in the wall tube and facilitated the stresses generated on the tube. Graphitization degraded the microstructure of the tubes, thereby reducing the mechanical performance. The combined effects of severe thermal oxidation and graphitization are attributed to the premature failure of the tube. Therefore, SA213 T22 should be used in the superheated zone. Regular monitoring and inspection of the conditions of the tube is also recommended.

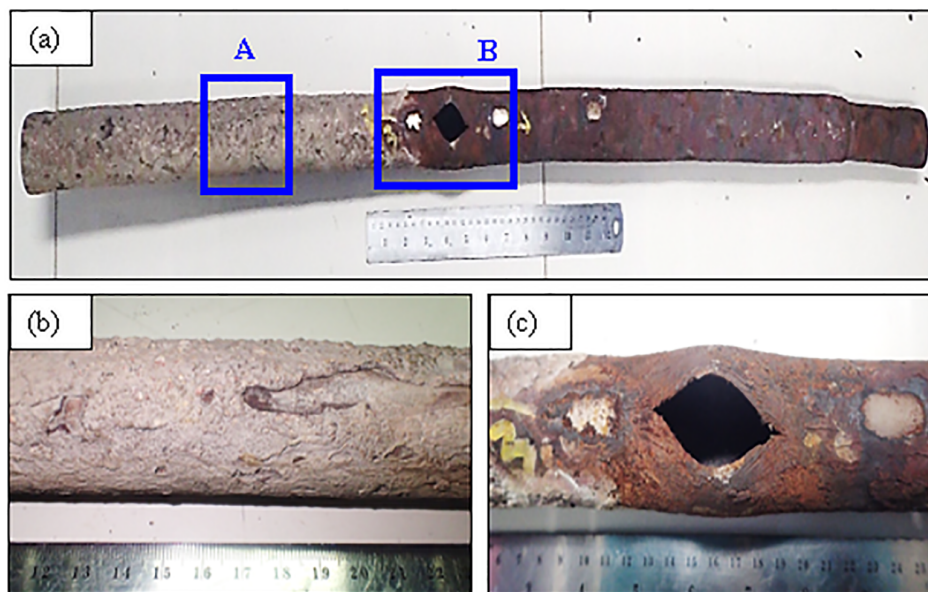
**Figure 1.** Photographs of failed superheater tube: (a) as-received failed superheater tube, (b) area “A” indicating oxide layers formed on the external surface of the tube and (c) area “B” showing wide-open burst with longitudinal direction

An as-received piece of the failed superheater tube is shown in Figure 1(a). This tube was covered with thick oxide layers in area “A” and a fish-mouth opening of the failed tube was observed at area “B”. Figure 1(b) shows thick oxide layers in area “A”. These thick oxide layers indicate excessive thermal oxidation, which can potentially occur during a long-term thermal exposure. The tube failed with a wide-open burst in the longitudinal direction (Figure 1(a)). The magnified

view of this failed area (Figure 1(c)) indicates thick-lip fish-mouth opening. The thick-lipped opening in the failed area of the tube indicated that the failure was mainly related to long-term overheating, and the tube eventually failed via stress rupture (Ahmad et al. , 2012; Saha and Roy, 2017). The failed tube was sectioned and examined at area 1 and area 2 as exhibited in Figure 2(a), to examine the outer surface conditions of the tube.

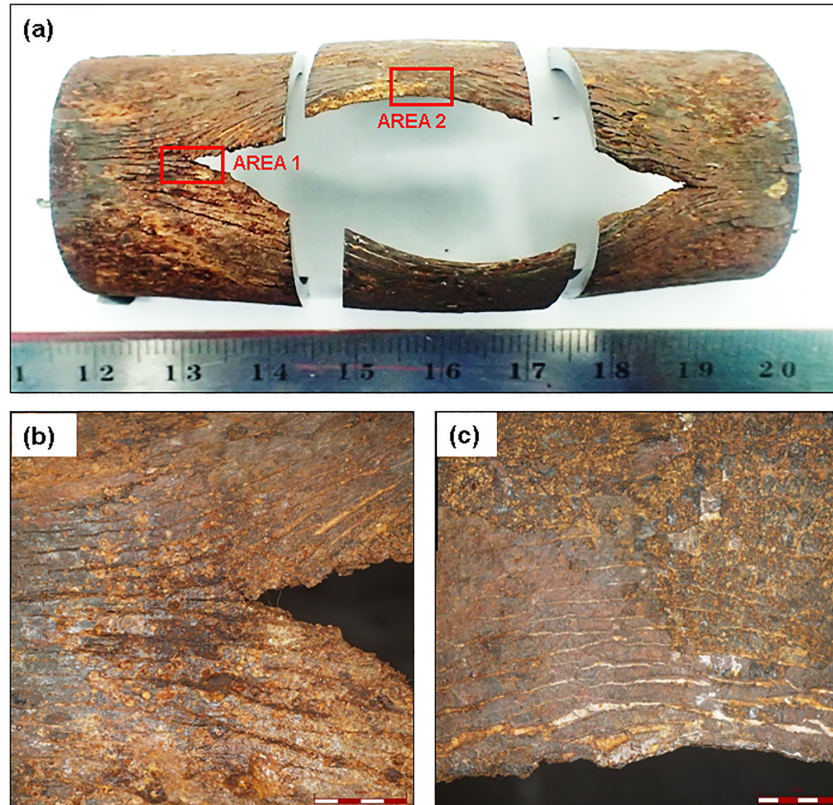
**Figure 2.** External surface of failed area: (a) failed area covered with oxide layers, (b) oxide layers cracked along tube-axis at area 1, and (c) oxide layers cracked along tube-axis at area 2

Figure 2(a) shows the external surface of the failed area of the tube. The failed area was covered with oxide layers, indicating excessive thermal oxidation. These layers had longitudinal cracks and spallation of oxide layers was also observed (Figure 2(b) and (c)). Typically, long-term overheating generates thermal stress and facilitates tube deformation (Sunandrioa, 2017). Hence,

longitudinal cracks and spallation of the oxide layers in this type of failure contributes to long-term overheating. In addition, the spallation of the oxide layers can cause wall-thinning of the tube, which subsequently generates excessive hoop stress on the tube (Haribhakti et al. , 2018).

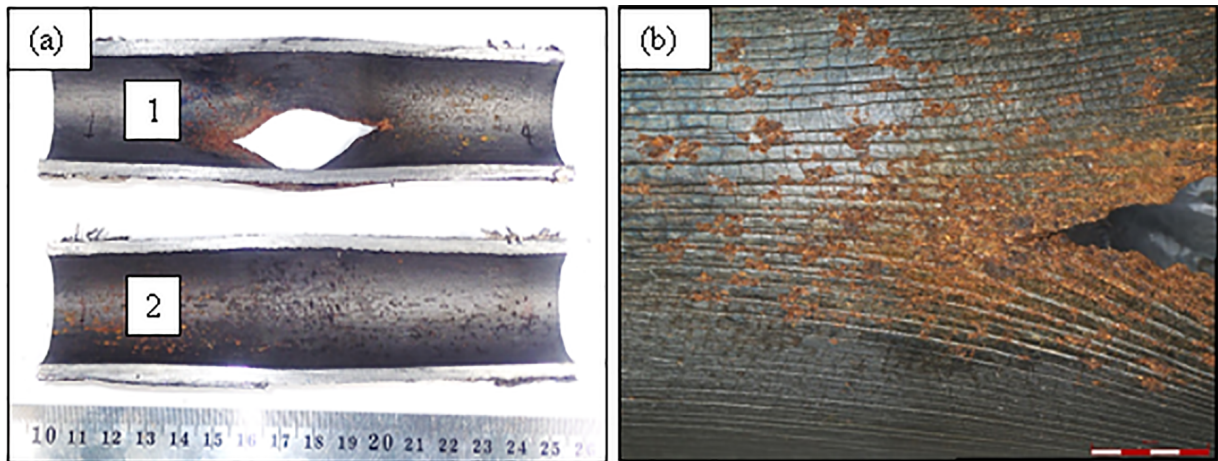
**Figure 3.** Internal surface of failed tube: (a) tightly adherent scale on internal surface and (b) longitudinal cracks of scale

Figure 3(a) shows the adherent scale on the internal surface of the tube. The longitudinal cracks on scale are shown in Figure 3(b). These cracks were promoted by tube bulging because excessive hoop stress was generated owing to thinning of the outer surface of the tube (Porta and Herro, 1991). Hence, this finding confirmed that the fracture of the failed tube and stress rupture were associated with long-term overheating.

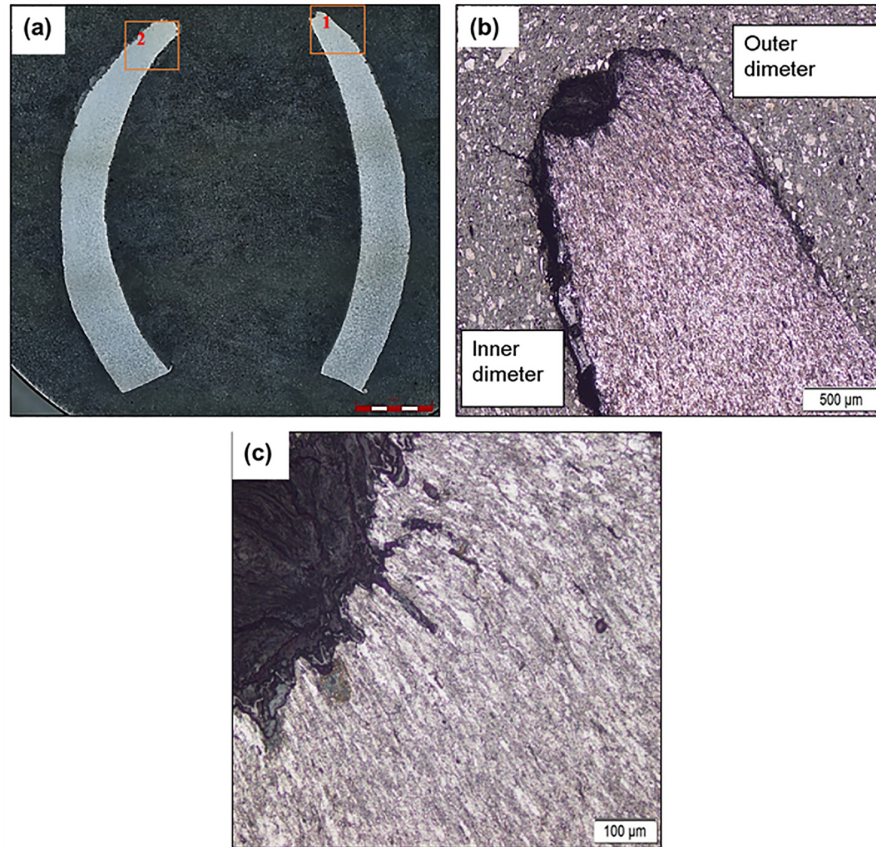
A cross-sectional sample for micrographic investigation was prepared from the failed area of the as-received failed tube. The positions for this examination are shown in Figure 4(a). As observed in Figure 4(b), the macrograph of the cross-section at area 1 exhibits a gradual decrease in thickness in the failed tube at the fracture edge, enhancing fish-mouth opening. Figure 4(c) shows

elongated grains near the fracture. These findings indicate plastic deformation before fracture. Microstructural examination was conducted on area 2, located in the mid-wall area of the sample. The results are presented in Figure 5(a) and 5(b). Figure 5(a) shows the microstructure under polished conditions, indicating random dispersion of the nodular-shaped phase throughout the polished matrix.

**Figure 4.** Macrograph analysis at area 1: (a) cross-sectional sample, (b) gradual decrease in thickness in failed tube and (b) elongated grains near fracture

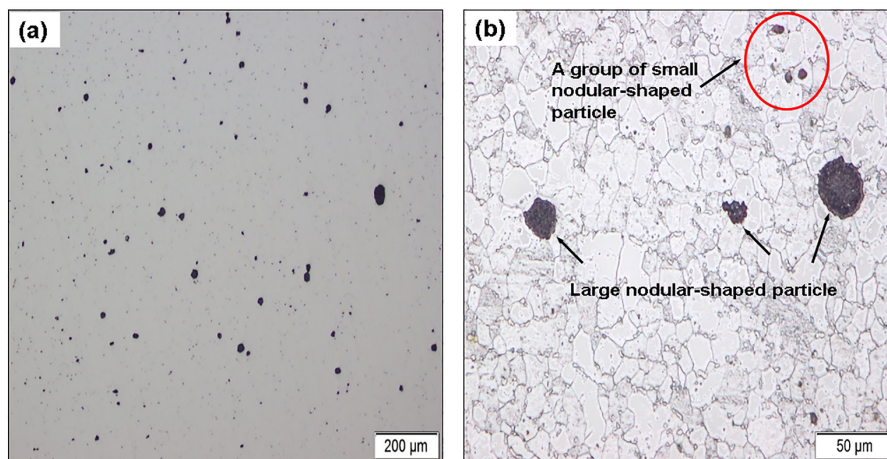
The microstructure of the etched sample prepared from the failed tube consisted of an initial ferrite–pearlite structure with a nodular-shaped phase, as shown in Figure 5(b). A cluster of small nodular-shaped particles was also observed (Figure 5(b)). The presence of the small and large sizes of the nodular-shaped particle indicates the microstructure alteration of the failed tube, known as “graphitization”.

**Figure 5.** Micrograph analysis at area 2 under (a) unetched condition and (b) etched condition

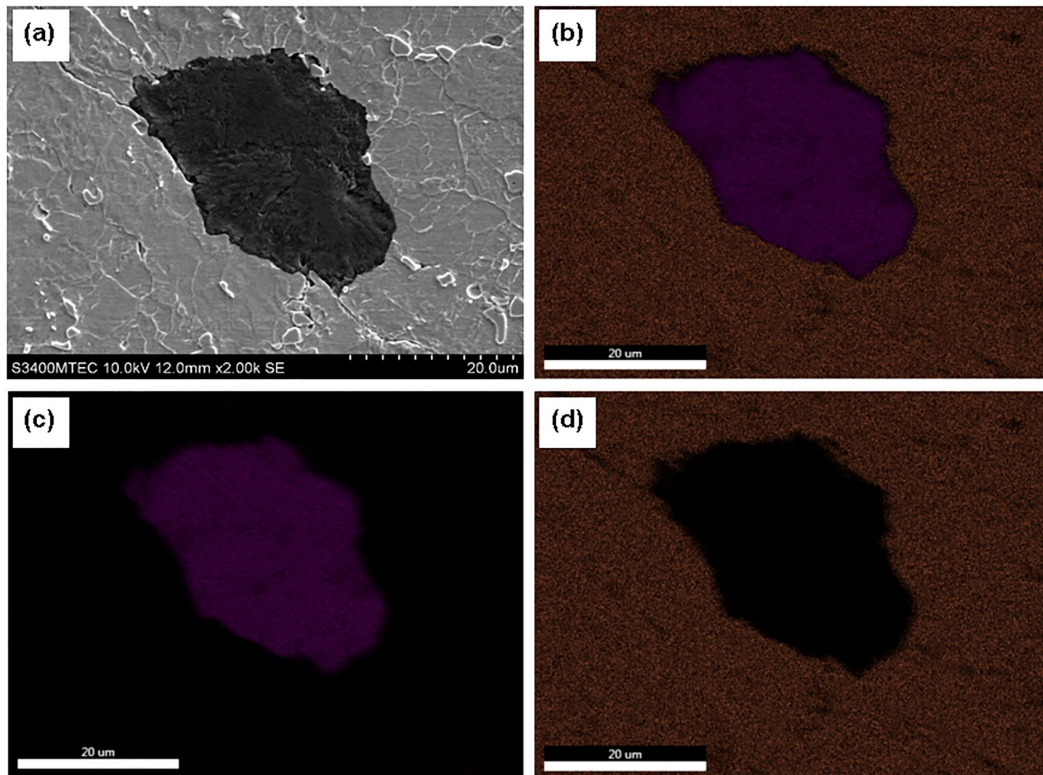
Figure 6 shows SEM micrographs of a nodular particle. The backscattering image (Figure 6(a)) shows the nodular particle labelled “A”, precipitated on the matrix labelled “B”. The element map overlay (Figure 6(b)) indicates the difference between the nodular-morphology particles and the matrix. Carbon accumulation was observed in the nodular particles. In addition, the distribution of Fe was detected (Figure 6(d)). Therefore, nodular particle A was composed of carbon, which might be nodular graphite. In contrast, the particle matrix consisted of Fe, indicating a ferrite structure. This finding confirms the degraded microstructure and suggests that the nodular-shaped particles observed in the micrograph analysis attributed to the formation of nodular graphite. The presence of small and large nodular-shaped particles indicate the initiation and growth of nodular graphite (Figure 5(a) and (b)). Therefore, graphitization can be attributed to the microstructural degradation of the failed tube. Pearlite is the main microstructure of boiler tubes and consists of lamellar ferrite and cementite (Haribhakti et al. , 2018). Lamellar cementite is responsible for the strength of the pearlite, which is directly related to the load-bearing capacity of the steel tube. However, after prolonged local heating in the temperature range of 427 to 580 °C, pearlite becomes unstable, and the degradation of this phase can take place (Porta and Herro, 1991).

Such extreme heat exposure promotes the transformation of cementite to free iron and nodular graphite, degrading the mechanical properties and pressure-bearing capacity of the heated tube.

**Figure 6.** SEM micrograph with EDS analysis of nodular graphite: (a) backscattering image, (b) element map overlay, (c) C distribution and (d) Fe distribution.

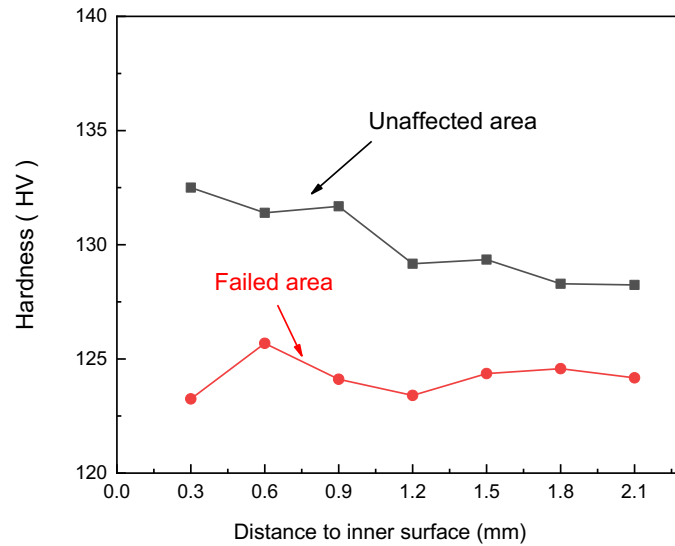
Micro-hardness measurements were performed on the failed and undamaged areas of the tubes. The hardness was measured at 7 points, (Figure 7). The hardness of the damaged area was significantly lower than that of the undamaged area. A reduction in the hardness of the failed area typically reflects degradation in the strength and integrity of the failed tube.

Figure 7. Micro-hardness results obtained from outer to inner surface measurements.

This result indicates the negative effect of prolonged local heating, which consequently accelerates the decomposition of pearlite into ferrite and randomly distributed nodular graphite. Ferrite is softer than cementite. Therefore, the microstructure degradation by the localized heating over a prolonged period of time is attributed to the reduced hardness and strength of the failed area of the damaged superheater tube.
