Metallurgical investigation of failed superheater tube used in thermal biomass power plant

ABSTRACT

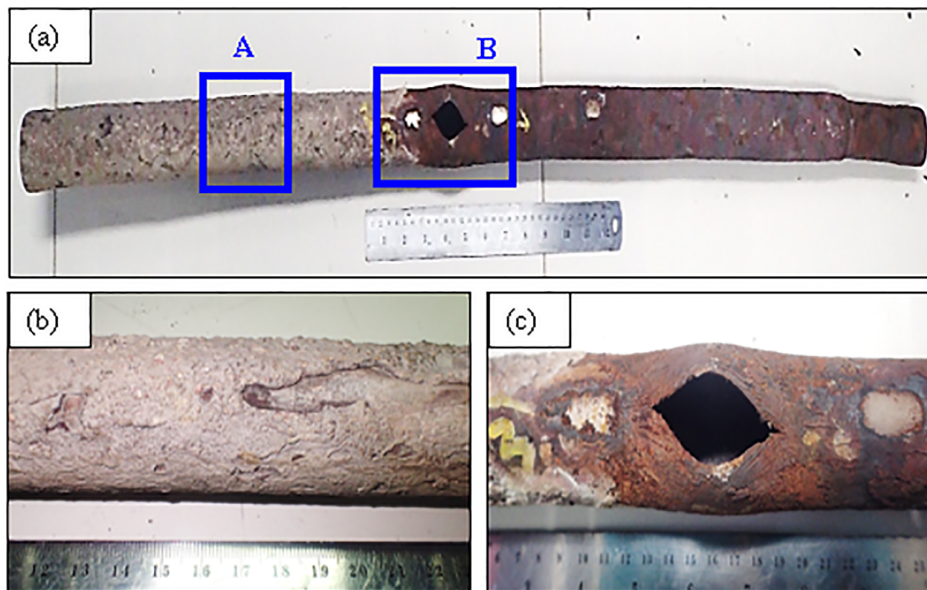
Figure 1. Photographs of failed superheater tube: (a) as-received failed superheater tube, (b) area “A” indicating oxide layers formed on the external surface of the tube and (c) area “B” showing wide-open burst with longitudinal direction

An as-received piece of the failed superheater tube is shown in Figure 1(a). This tube was covered with thick oxide layers in area “A” and a fish-mouth opening of the failed tube was observed at area “B”. Figure 1(b) shows thick oxide layers in area “A”. These thick oxide layers indicate excessive thermal oxidation, which can potentially occur during a long-term thermal exposure. The tube failed with a wide-open burst in the longitudinal direction (Figure 1(a)). The magnified

view of this failed area (Figure 1(c)) indicates thick-lip fish-mouth opening. The thick-lipped opening in the failed area of the tube indicated that the failure was mainly related to long-term overheating, and the tube eventually failed via stress rupture (Ahmad et al. , 2012; Saha and Roy, 2017). The failed tube was sectioned and examined at area 1 and area 2 as exhibited in Figure 2(a), to examine the outer surface conditions of the tube.

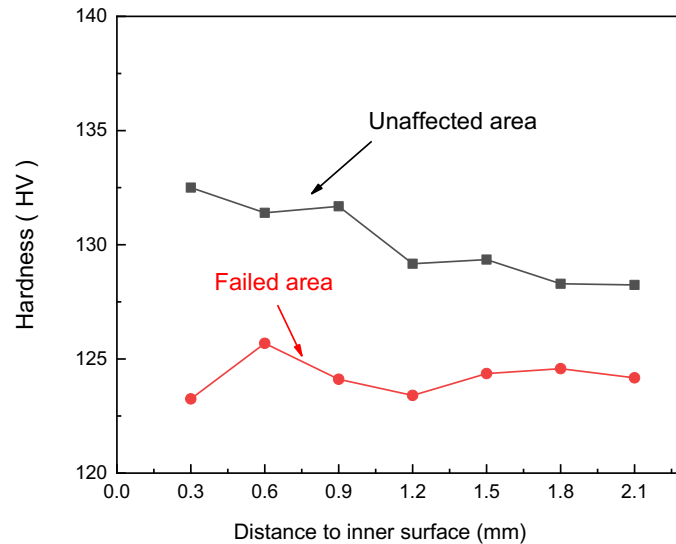
Micro-hardness measurements were performed on the failed and undamaged areas of the tubes. The hardness was measured at 7 points, (Figure 7). The hardness of the damaged area was significantly lower than that of the undamaged area. A reduction in the hardness of the failed area typically reflects degradation in the strength and integrity of the failed tube.

Figure 7. Micro-hardness results obtained from outer to inner surface measurements.

This result indicates the negative effect of prolonged local heating, which consequently accelerates the decomposition of pearlite into ferrite and randomly distributed nodular graphite. Ferrite is softer than cementite. Therefore, the microstructure degradation by the localized heating over a prolonged period of time is attributed to the reduced hardness and strength of the failed area of the damaged superheater tube.
