3D modelling and visualization of large building using photogrammetric approach

The aim of this study is to make a virtual 3D model of the College of Engineering, University of Duhok, Kurdistan Region, Iraq. The data input is vertical and oblique imagery acquired by UAV, with the ground control points being distributed on the surrounded ground, facades, and roof. Ground control points were measured by the GPS RTK system in addition to the reflectorless total station instrument. The data is processed mainly using Agisoft PhotoScan software as well as the Global Mapper and the ReCap software. The output is a 3D model, digital elevation model, and orthomosaic. Geometric and visual inspections were carried out. Some imperfections appeared on the sharp edges and parapets of the building. In the geometric accuracy of selected points on the building, the maximum standard deviation in the coordinates was ± 4 cm. The relative accuracy in distance measurements was in the range from 0.72% to 4.92 %.

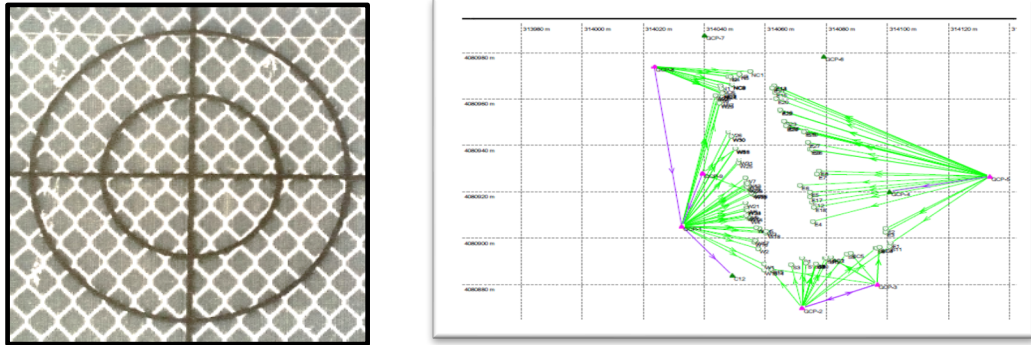
Figure 1a. Self-adhesive card target. **Figure 1b.** The distribution of the GCPs.

A total of 92 self-adhesive 10*10 cm paper card targets (Figure 1a) were fixed as control points on the building's external walls and windows. The targets were distributed evenly to ensure good coverage of control points all over the building. The coordinates of these points were measured using the Leica TCR1101 total station in a reflectorless mode. According to the manufacture specifications, the instrument has an accuracy of $\pm 1.5''$ in angle measurements, distance accuracy of $\pm 3\text{mm} \pm 2\text{ppm}$, and a measuring range = 80m in the reflectorless mode.

The total station was positioned on the 9 GCPs (Figure 1b) from which the paper targets were observed and recorded using the SD card memory attached to the instrument.

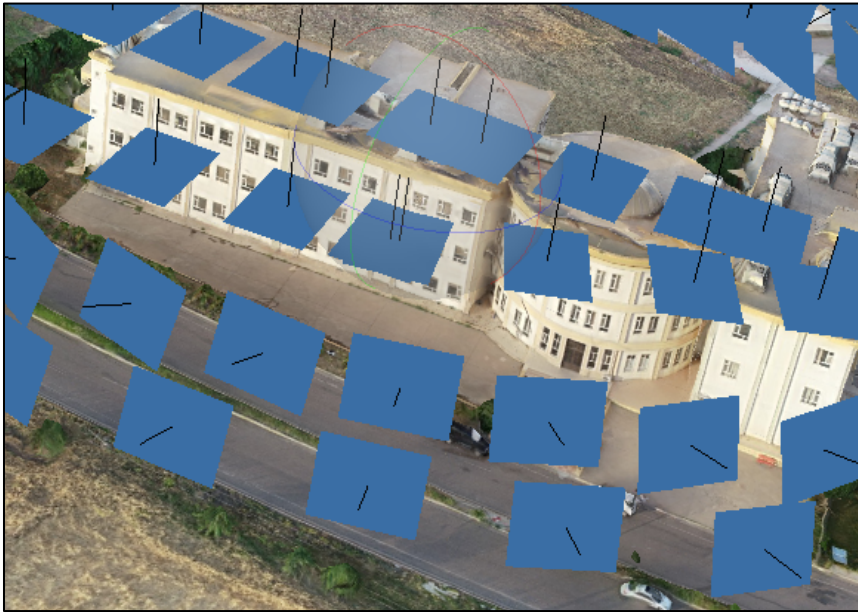
Figure 2. The 4 flight strips surrounding the building.

A total of 183 images were acquired for the building and the surrounded area. The software Pix4D Capture was used for flight planning. The coverage was acquired in 4 flights. Two flights were oblique, and the other two were vertical as shown in Figure 2. The first flight was set to take images at a distance of 35m from the building facades at a height of 22m from ground level with the camera depression angle of 22° from the horizon.

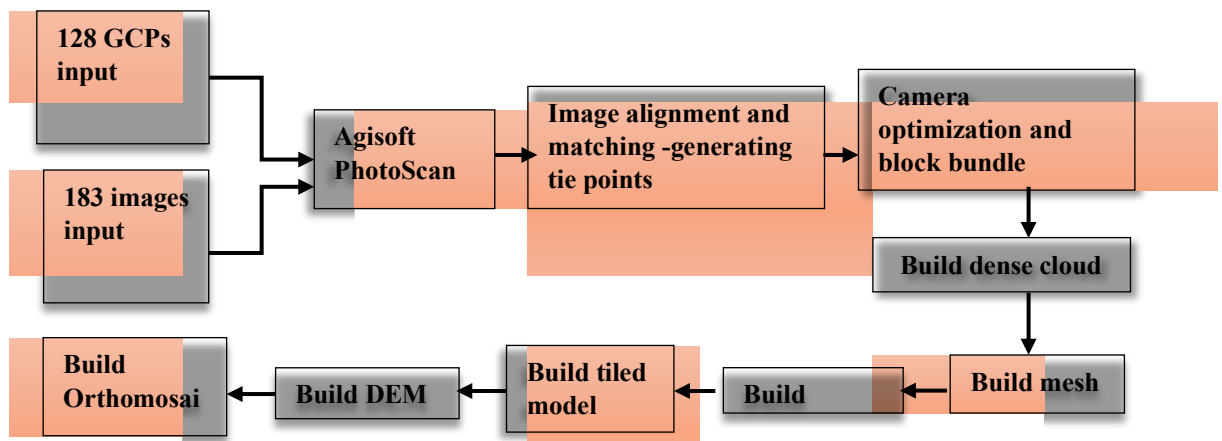
Figure 3. The Agisoft PhotoScan working flow diagram.

The Agisoft PhotoScan software was used to process the data and acquired the building 3D model. The input was the 183 images and the 128 GCPs (markers). The processing flow diagram is shown in Figure 3. One step in constructing a 3D model in Agisoft PhotoScan software and after aligning the photos is the selection of the control points on the overlapped images. On selecting the point on the first image, the epipolar line will appear passing through the corresponding point on the second image (Figure (3.9)). This will indicate the degree of matching accuracy.

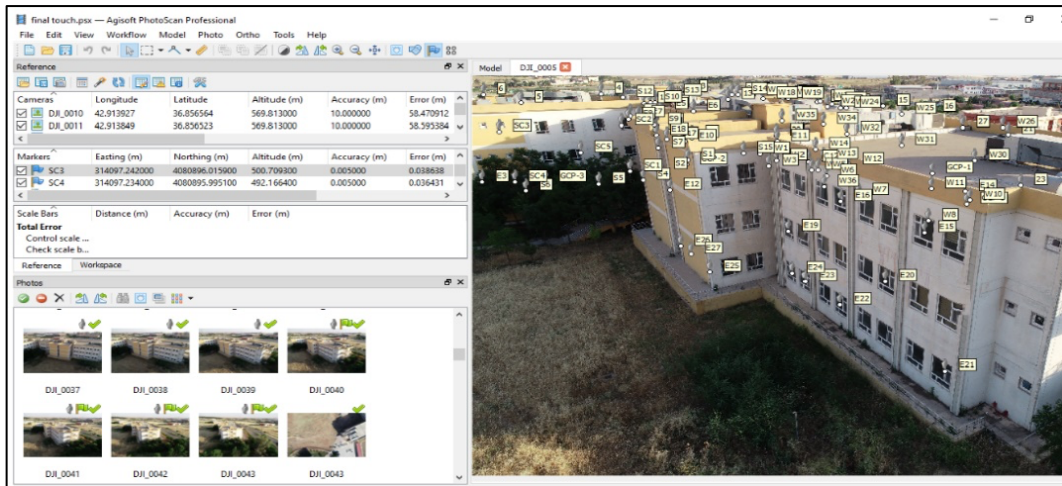
Figure 4. The Agisoft PhotoScan active window.

Figure 4 shows the Agisoft PhotoScan active window. The window can show the selected image, the model, workflow, images perspective centers, and GCPs details.

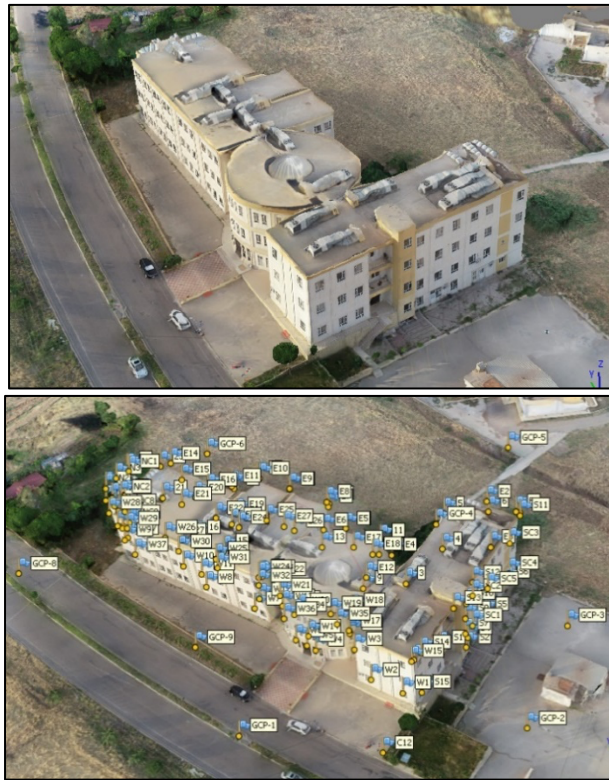
Figure 5a. The finished tiled model. **Figure 5b.** The model with control points.

The medium quality process of the dense cloud took approximately 2 hours. Figure 5a shows the tiled model, while Figure 5b shows the tiled model with a GCPs marker.

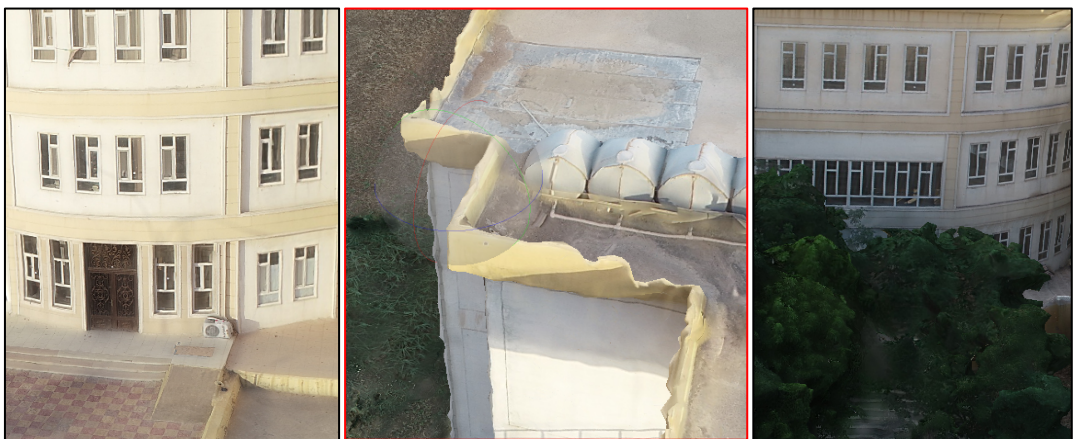
Figure 6a. Part of the model showing the apparent model quality. **Figure 6b.** Parapet and corners distortions. **Figure. 6c.** Obstruction by trees.

Most of the building details appeared perfectly well. In Figure 6a, however, limited deformations have been noticed on some straight edges like top roof parapets and some corners (Figure 6b). Obstructions like trees (Figure 6c) prevent overlapping images and control measurements. Details behind these obstructions appear largely deformed.

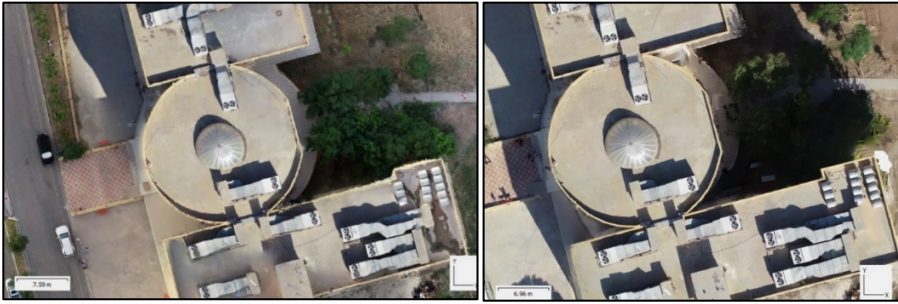
Figure 7a. Medium quality dense cloud model. **Figure 7b.** Ultra-high-quality model.

Figure 7a shows the part of the building top view with medium quality dense cloud. Figure 7b shows the same view but processed in ultra-high-quality dense cloud. On changing to ultra-high-quality processing, there is a clear improvement in image fidelity. However, distortion in the building parapets was also obvious.

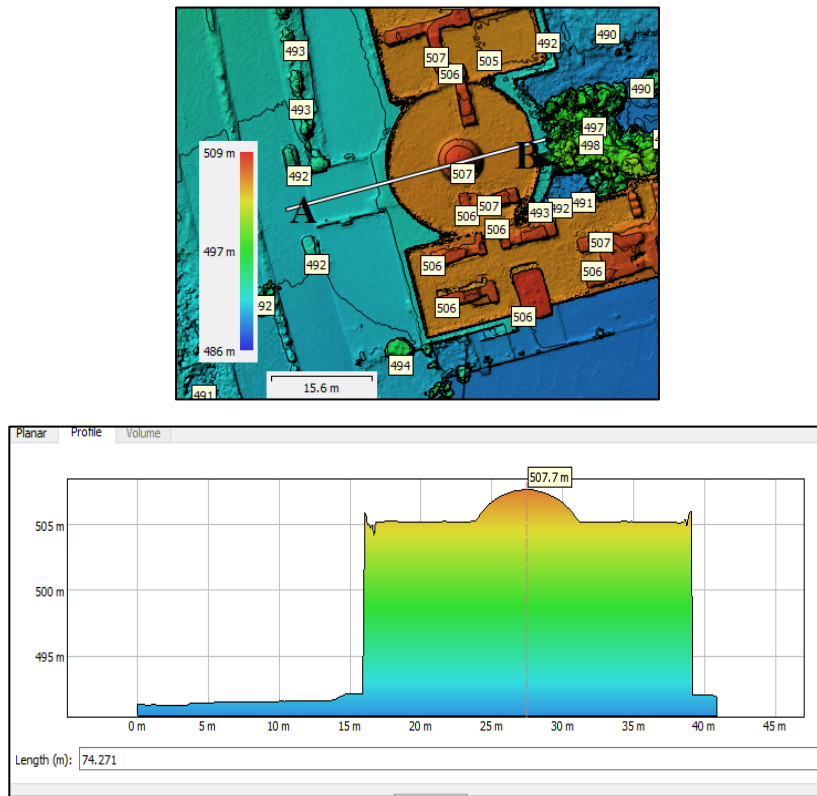
Figure 9a. Location of the profile AB. **Figure 9b.** The produced profile with color coded.

A profile can be generated by drawing a polyline across any part of the DEM or the orthomosaic in the desired position, line AB Figure 9a, producing the profile in different colors for different elevation ranges.

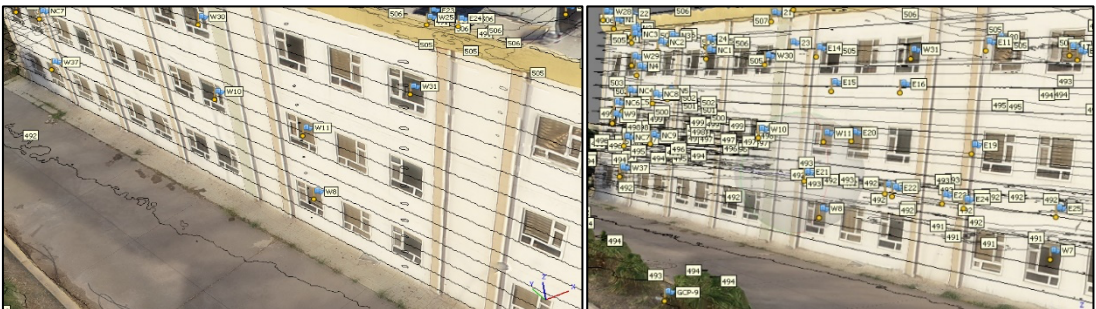
Figure 10a. Tiled model with 1m contour lined.
Figure 10b. The back façade contour lines appear on the front façade.

Vertical walls of the building produce parallel contour lines, which appear in the model perspective view. These contours are not diffused with the natural ground contours. Figure 10a shows the building western façade with 1m interval contour lines. Further orbiting the model will show the contours of the other side of the building plus the natural ground contour lines behind the building (Figure 10b). The building transparency might be considered as a software drawback to be treated.

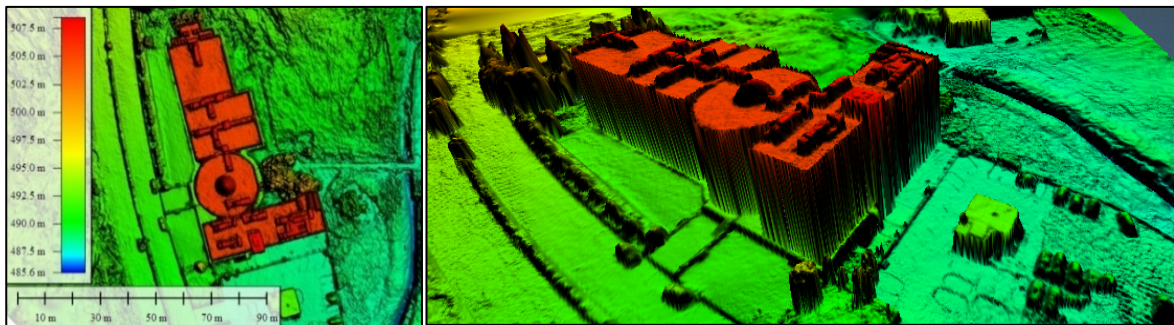
Figure 11a. Global Mapper produced color coded DEM. **Figure 11b.** 3D view.

The DEM was exported with the same point density of 7228x7228 and the same resolution of 4.74cm/pix in a TIFF format to the Global Mapper software producing a more enhanced texture image (Figure 11a). Figure 11b shows a 3D view produced by the same software using the DEM data only and height codes.

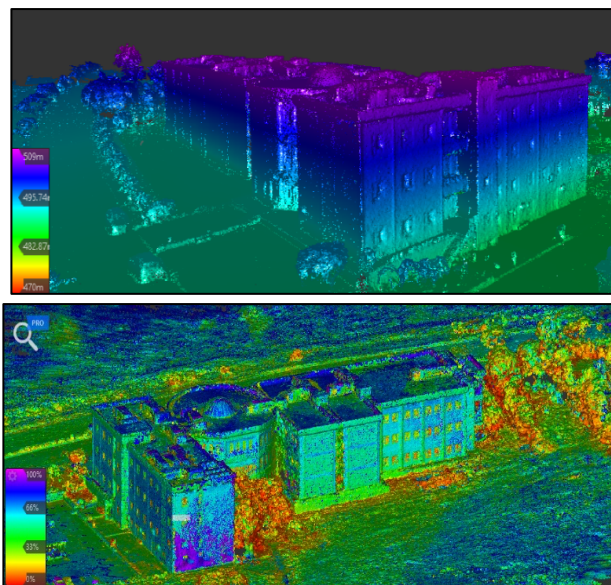
Figure 12a. ReCap produced 3D view with colored coded heights.

Figure 12b. The model with light intensity color coded.

The generated dense cloud is saved in ASPRS LAS (*.las) format and exported to the Autodesk ReCap program. In the ReCap software, a 3D model is produced in different forms. Figure 12a shows the model built with specified colors of points based on height. Figure 12b shows the model built with specified colors of points based on the intensity value.

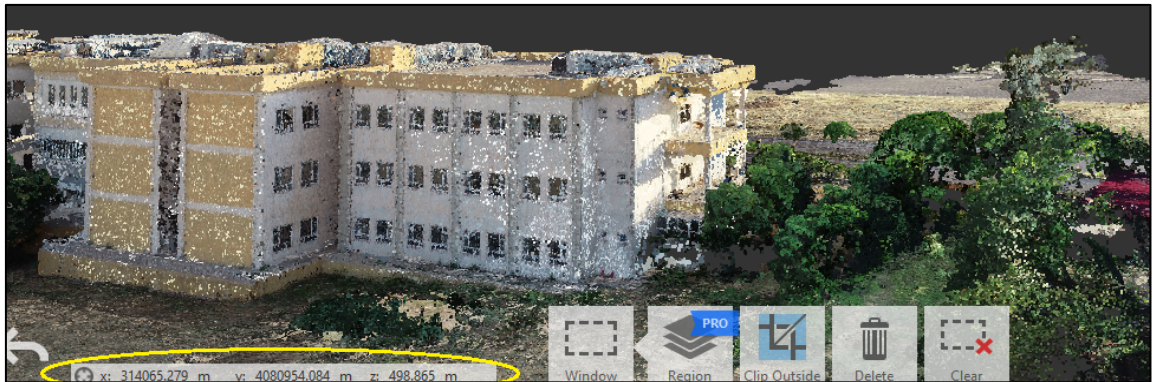
Figure 13. ReCap generated 3D model allowing to measure the coordinates of any point on the facades.

As a mean to check the geometrical accuracy, the 3D model generated by the ReCap software was used. It was possible to locate the cursor at any point on the model and read its coordinates, as shown in the margin of Figure 13. These coordinates were compared with the measured GPS coordinates. It was possible to identify 8 control points on different building facades. The discrepancy between the two sets of coordinates is tabulated in Table (4). The standard deviation in any of the 3 three coordinates does not exceed $\pm 4\text{cm}$.

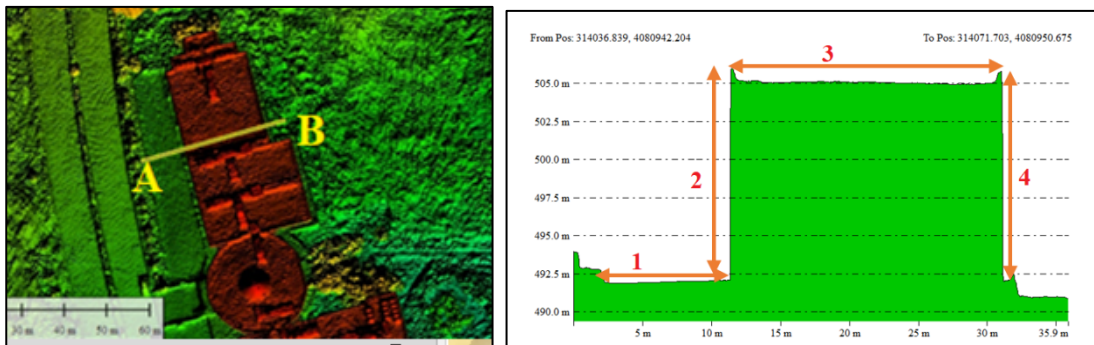
Figure 14a. Position of the profile line AB on Global Mapper model. Fig. 14b. The produced profile.

Figures 14a and 14b show the location and distances of the profile AB, which are measured on the Global Mapper profile. Figure 15a shows the location of the profile CD in an outside stair on the south side of the building. One height marked with the number 5 is measured on the model and directly on the building. Results of these measurements are given in Table 5.

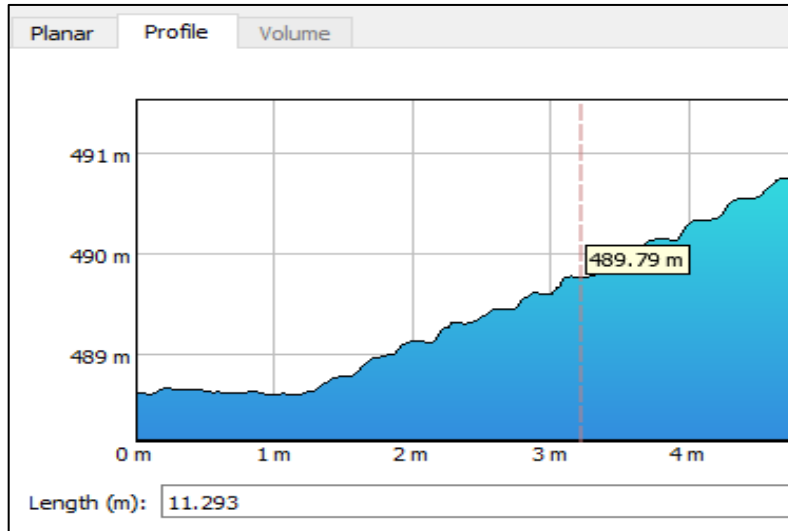
Figure 16. Stair profile produced using ultra-high-quality dense cloud.

Examining the stair profile (Figure 15b), it is clear that the steps that had a height of 18cm did not appear clearly on the profile. Repeating the model processing but with ultra-quality in dense cloud generation, a profile, shown in Figure 16, is produced

Figure 16 shows the appearance of the stair steps; although it shows irregularity in shape to some extent, the average height of the steps was 17cm measured on the model, which is not far away from the actual 18cm height.

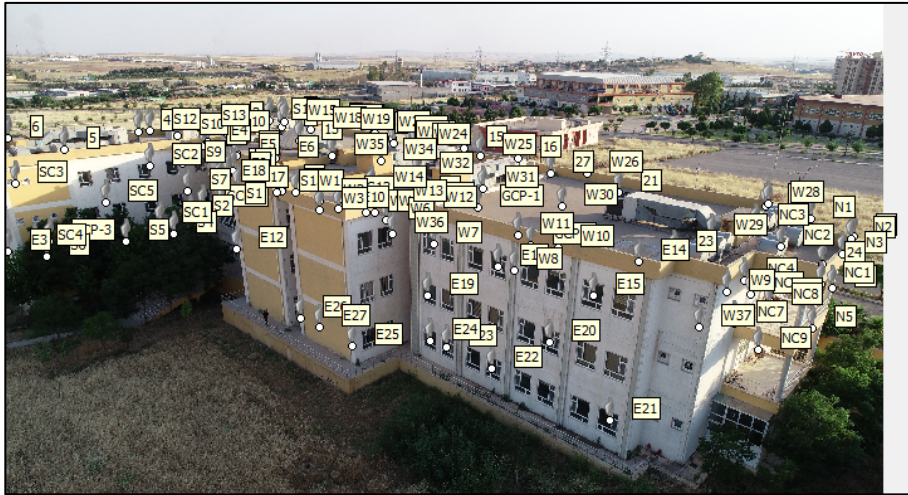
Figure 17. The east side control points; the control points of the west and south facades appear as well.

- 4- On adding GCPs for the process of georeferencing in the PhotoScan, the images on which the points are being selected display all the front side and backside control points. Figure 17 shows the building's east façade image under processing and control point's location. In addition to the east side control points, the control points of the west and south facades appear as well. The research team noticed that the same remark took place on the building model. This point might be considered as a drawback in the software design to be treated, as the model appears transparent, showing all sides of the control points.
