Performance of quadrilateral perforated prestressed concrete rafters

This study focuses on the behavior of simply supported perforated prestressed concrete rafters (PPCRs) under single midspan monotonic static loading. The experimental program consists of testing seven specimens, one solid (control) rafter, and six perforated quadrilateral openings. The main investigated variables are the number and height of the openings. The test findings indicate that, in comparison to the solid rafter, the presence of quadrilateral openings in the PPCRs led to reducing the load capacity by (4.3-36%) and increasing the midspan deflection at ultimate by (14.8-33%). Also, increasing the number of concrete posts between openings resulted in increasing the failure load and decreasing the deflection at all stages of performance of the prestressed concrete rafter. On the other hand, decreasing the depth of the upper and lower chords by 25% for PPCRs with the same number of openings led to a reduction in the failure load by 36, 29.5, and 24.5% for rafters with 6, 8, and 10 openings, respectively.

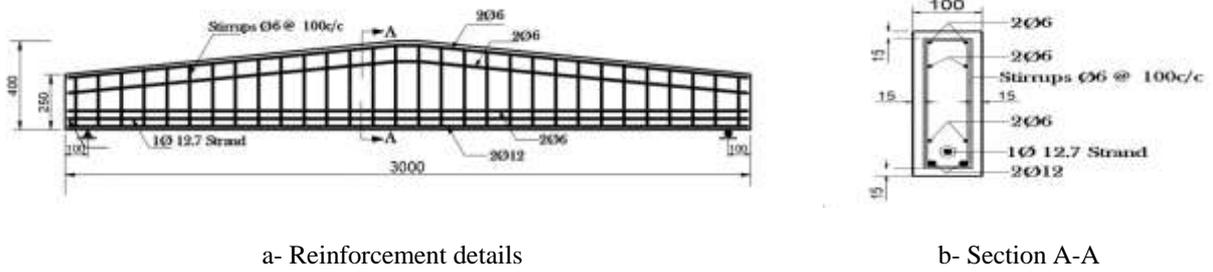
Figure 2. Reinforcement details for non-perforated beam PGB (dimensions are in mm).

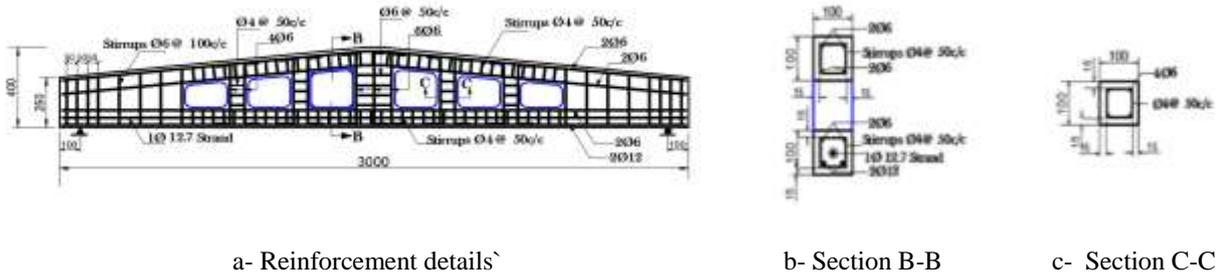
Figure 3. Reinforcement details for the perforated beam of groups A and B (dimensions are in mm).

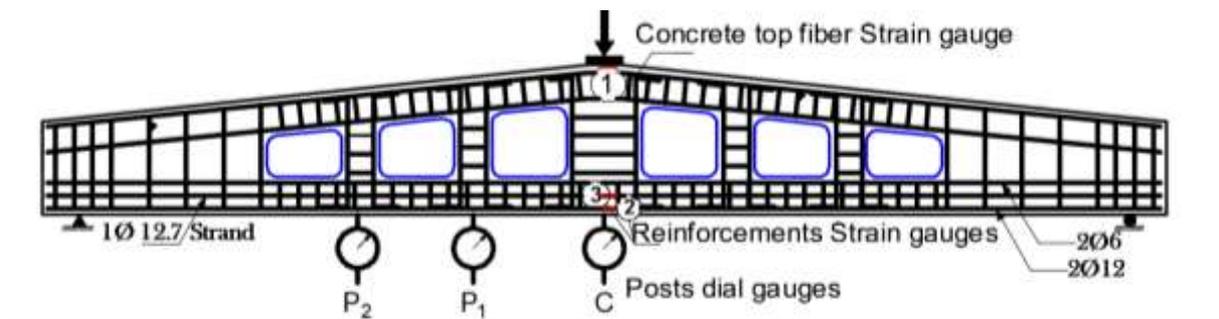
Figure 4. Instrumentation of tested rafters.

A self-equilibrium steel frame was used to test the rafter specimens. The applied single midspan load was monotonically increased up to failure through a hydraulic jack of 1000 kN capacity. The strain and dial gauges were attached to their specific locations to measure strain and deflection, respectively (Figure 4). The readings of strains and dial gauges were monitored at the end of each load increment. Also, at each loading increment, crack width was fixed, and at the end, the failure load was reported.

To detect the behavior via the stress that was generated in the rafter's elements, electrical resistance strain gauges were fixed at different locations and levels of the rafter members, on concrete surface and steel reinforcements (mild steel and strand), as shown in Figure 4.

Strains were measured for the lower layer of steel reinforcement at the midspan section (strain gauge number 2); see Figure 4. Figures 13 and 14 demonstrate the strain in this type of steel, where the presence of openings in the perforated rafter increases the steel bars strains at all loading stages. It can be noticed that the increasing ratio of midspan strain at loading stage 40 kN ranging between 21.6–95.8% while it was 34.7–11% at load stage of 80 kN relative to the strain in such steel in the nonperforated specimen. These increments can be interpreted by the fact that the creation of openings in the rafter reduced the cross-sectional area and moment of inertia, which led to a decrease in the rafter's overall stiffness.

The strain in the prestressing strand has been measured using an electrical strain gauge at the midspan section as mentioned earlier (strain gauge number 3); see Figure 4. Table 4 shows effective stresses and strains for

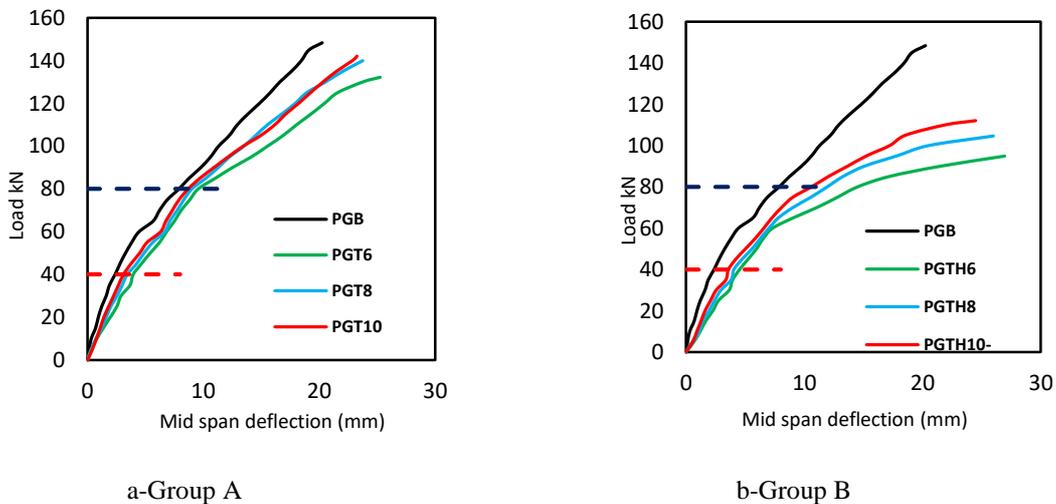
Figure 5. Load-deflection curves for main groups (A) and (B).

Three stages of loading were selected to investigate the response of the tested prestressed concrete rafters, mainly, the uncracked elastic stage (40 kN), service stage (80 kN), and ultimate loading stage. Table 3 and Figure 5 reveal that the presence of openings in PPCR increases the deflection at all loading stages. This observation is verified by the incremental ratio of the deflection relative to the PGB. But these ratios decrease in each group with increasing openings number extended at the same beam length. In all groups, the PPCR with ten openings was the closest to that of the PGB, followed by specimens with eight then with six openings. On the other hand, decreasing openings height as in Group A, the rafters behavior approach to PGB, in contrast, a higher deviation was observed for those of Group B. Additionally, the following observations can be driven: PPCRs behaved linearly (elastically) before cracking, and the slope of linear parts was slightly different for specimens of each group. While more cracking has been observed, the behavior gradually changed from linear to nonlinear, and then the slope of the curves of each group was, therefore, substantially deviated.

In comparison to solid rafter PGB, the creation of openings led to increasing the deflection of PPCRs at different stages of loading. The increase of deflection at elastic, service, and ultimate loads ranged between 30.6–90.7%, 10.2–84.2%, and 14.8–33.1%, respectively, for PPCRs relative to the solid rafter.

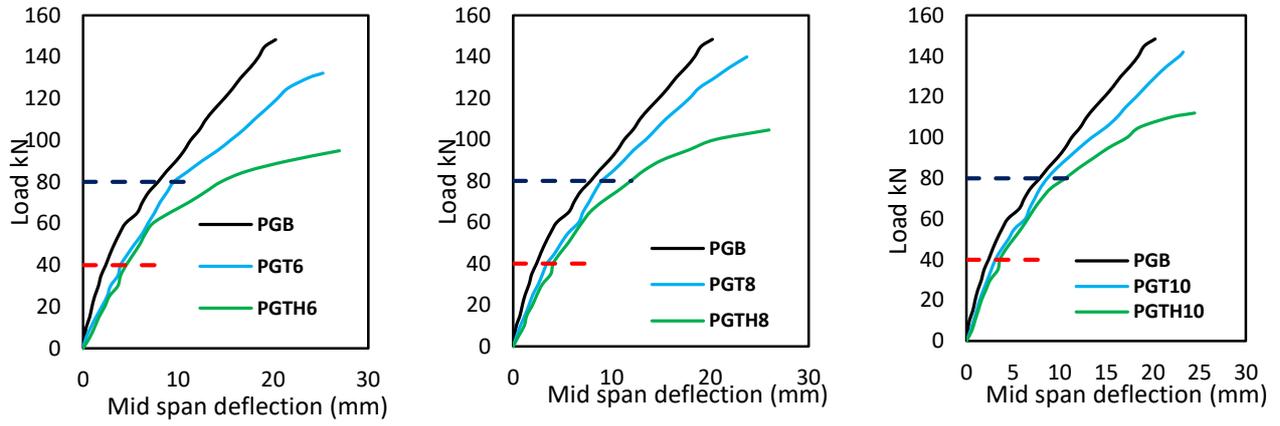
Figure 6. Load-deflection curves for comparative Group C.

Another comparative group (Group C) has been classified in Table 3 to reveal the effect of openings height by comparing rafters having the same openings number but differing in openings height (i.e., 25% variation in chords depth). It can be found that the deflection at midspan was increased with the increase of the height of the opening because the PPCR stiffness is greatly affected by the two chords' depth. The behavior of the specimens in Figure 6 is verifying these observations, where PPCRs with the lesser chord depths have the lesser stiffness.

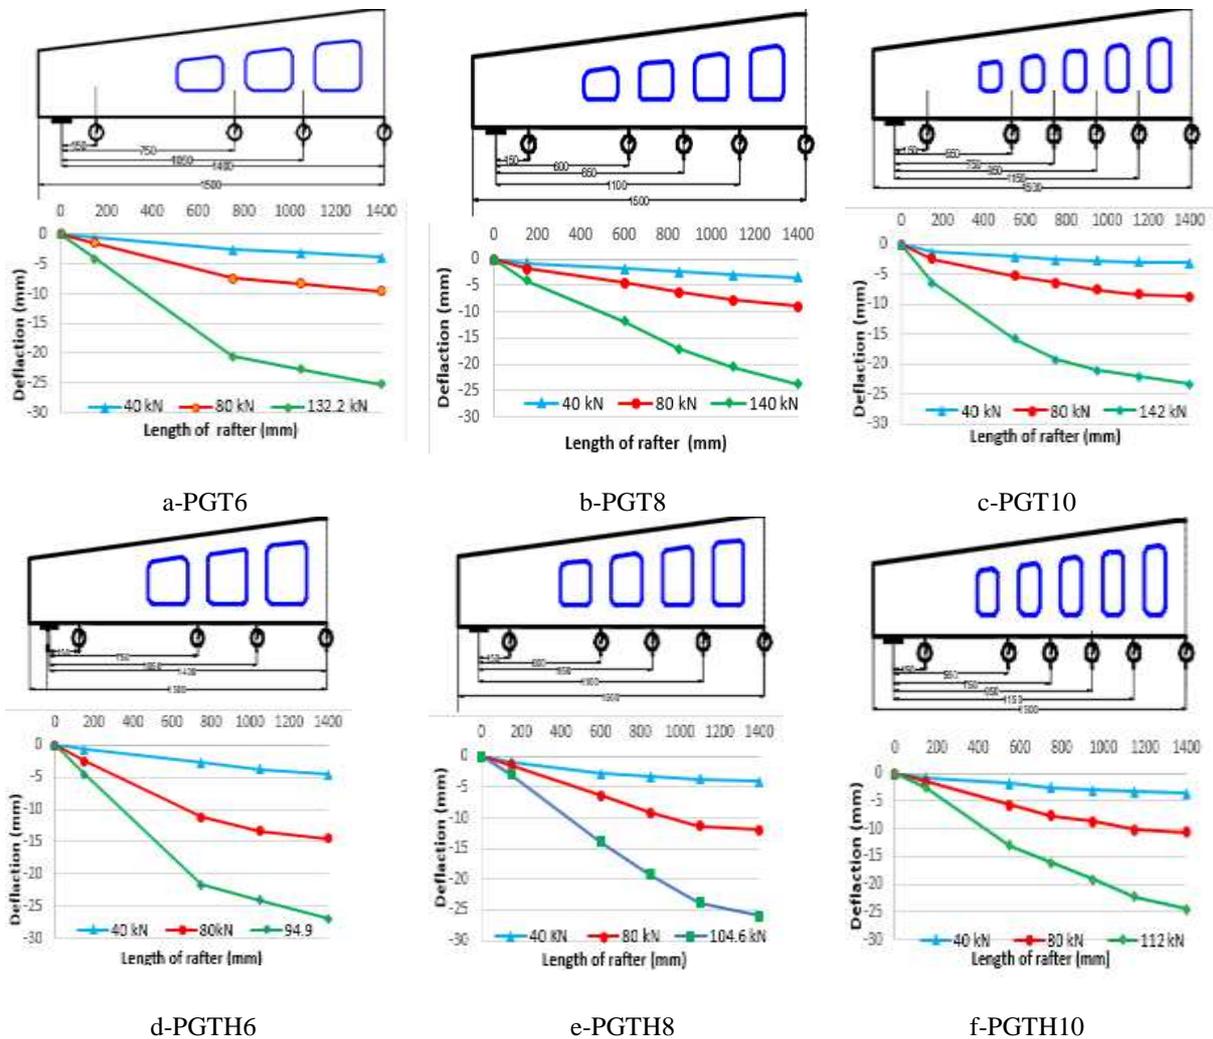
Figure 7. Deflection profile of the tested rafters.

Deflection along the tested beams at each post (node) has been measured at three loading stages (40, 80

kN, and ultimate load) as demonstrated in Figure 7. These curves recognize that the high deflection progress was monitored at the first and second posts next to the support. This deflection mainly occurred at the portions between the posts (openings zone) due to the drop in the overall stiffness as a result of the creation of openings.

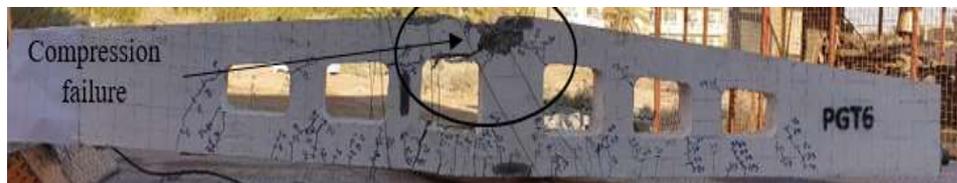
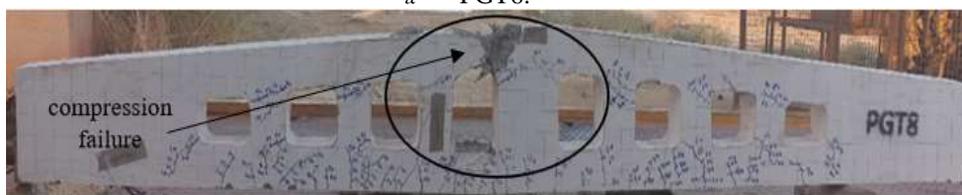
Figure 9. Failure mode of Group A rafters by diagonal splitting failure at opening corners followed by compression failure.

happened. Four types of cracking patterns were formed in the perforated rafters, mainly, opening corner cracks, shear cracking at chords, flexural cracking in chords, and cracking of tension chord. One of these types of cracking developed and propagated more than the others. Accordingly, various modes of failure due to these cracking patterns were observed. As a result, two different modes of failure happened. The first was a diagonal splitting crack at the corners, where the corner cracks propagated and developed toward the loading point and to the nearest support, followed by compression failure, as in specimens PGT6, PGT8, and PGT10. While the second mechanism of failure was caused by the formation of plastic hinges adjacent to the openings in many of the chords of the rafters, these successive plastic hinges affect the curvature of the beam, followed by posts shear failure. Stresses will, therefore, be redistributed to larger parts of the rafter that participated in the Vierendeel action in flexural strength, such as in rafters PGTH6, PGTH8, and PGTH10. Figures 8, 9, and 10 illustrate the mode of failure and crack patterns for each of the tested beams.

6. The mode of failure of specimens of group A was by diagonal splitting cracking at corners of opening; however, increasing openings height in group B changed the mode of failure to a formation of plastic hinges, which led to shear posts failure.

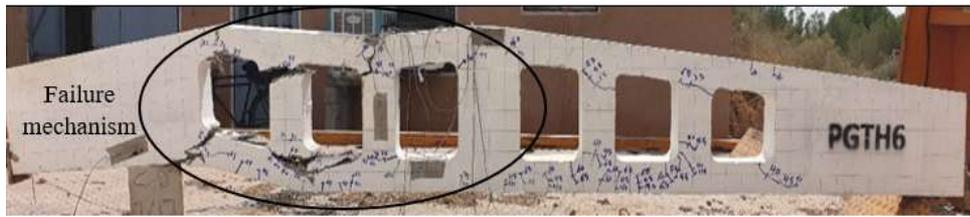
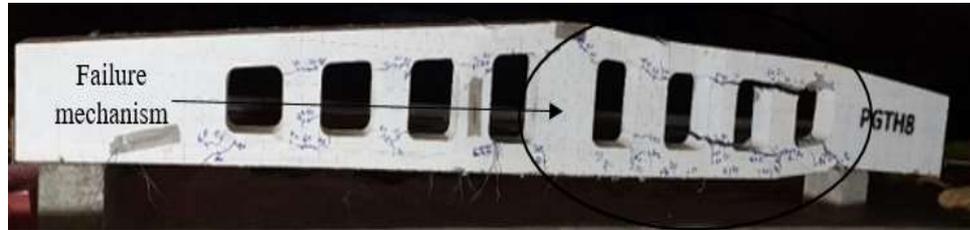
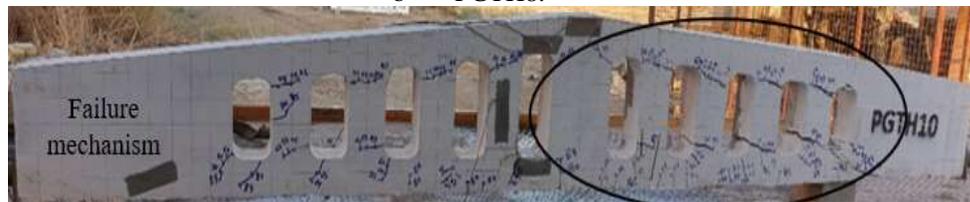
Figure 10. Failure mode of Group B rafters by plastic hinges and posts shear failure.

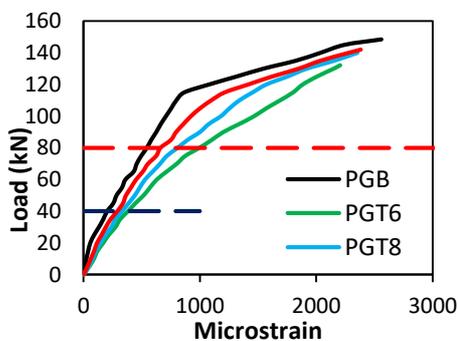
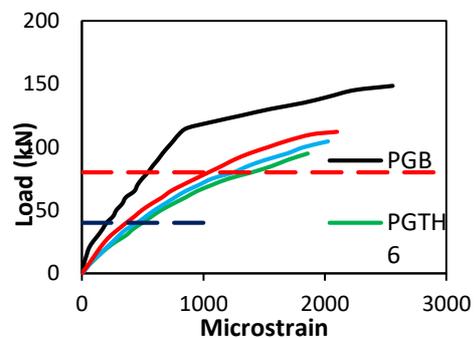
Figure 11. Load versus midspan compressive strain at top of concrete for groups A and B.

Figure 11 illustrates, for all rafters, the load versus midspan compressive strain at the concrete top surface (strain gauge number 1) for loading stages of 40, 80 kN, and the ultimate load.

For the same opening's height (Groups A and B), increasing the number of openings to 8 and 10 led to a decrease in the average concrete compressive strain by 12 and 25%, and 15 and 30% for loading stages of 40 and 80 kN, respectively. This might be due to minimizing the total area of openings and increasing the number of posts, which have a beneficial effect on the strength of the rafter. Figure 12 reveals that differences happened for the rafters with the same number of quadrilateral openings but differ in their height (Groups C). It can be seen that increasing openings height (i.e., decreasing upper and lower chords by 25%) led to a significant increase in concrete compressive strain for all loading stages.

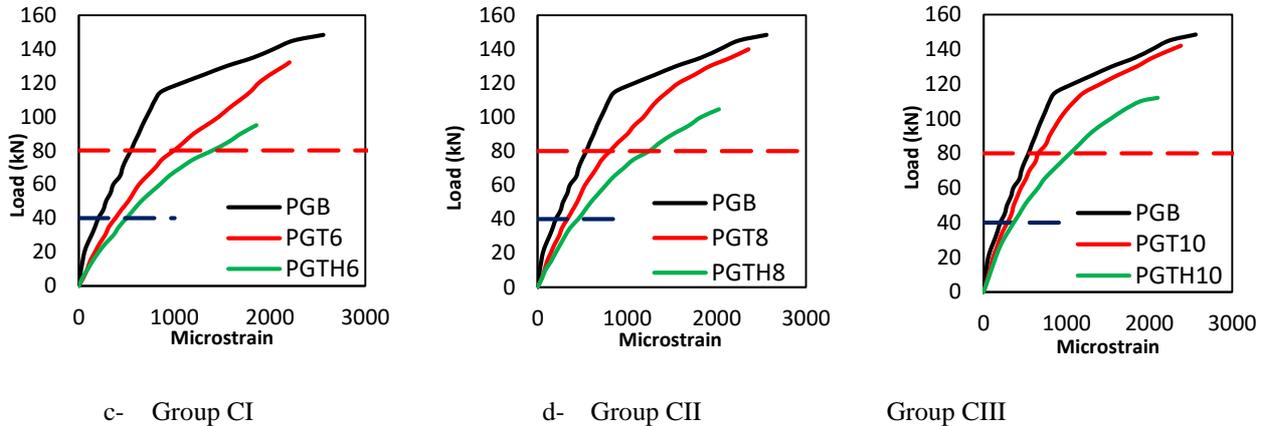
Figure 12. Load-midspan compressive strain in extreme concrete fibers for group C.

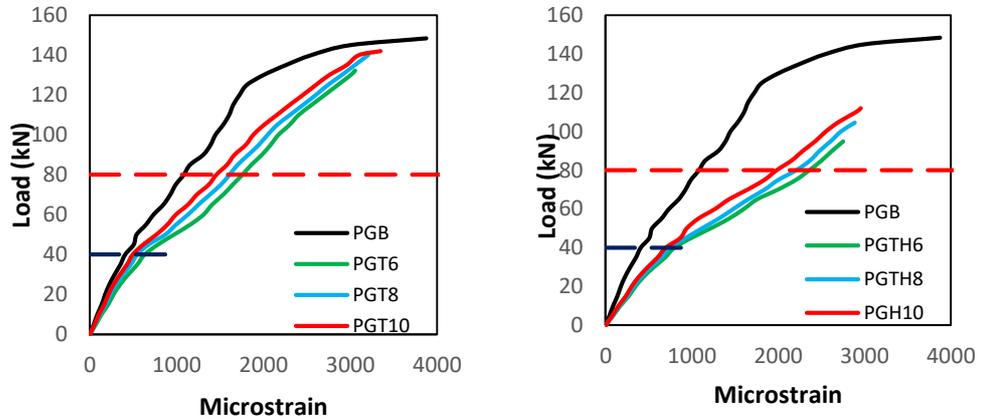
Figure 13. Load-strain in steel bars for groups A and B.

According to the tensile test results for steel reinforcements, which were performed on 12mm bars diameter (Table 2), the yielding strain is 3000 Microstrain thus, at ultimate load, the steel in the nonperforated rafter (PGB) yielded, and all perforated rafters also reached this limit or approached to that such as PGTH6, PGTH8, and PGTH10.

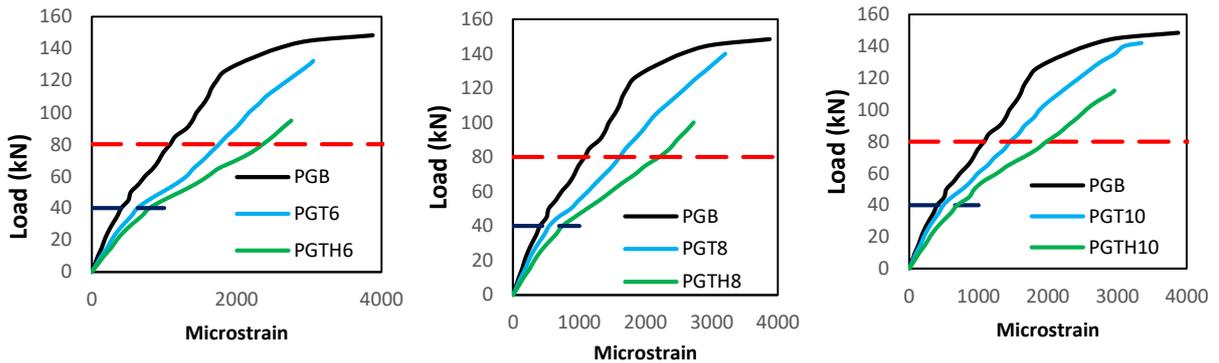
Figure 14. Load-strain in steel bar for Group C.

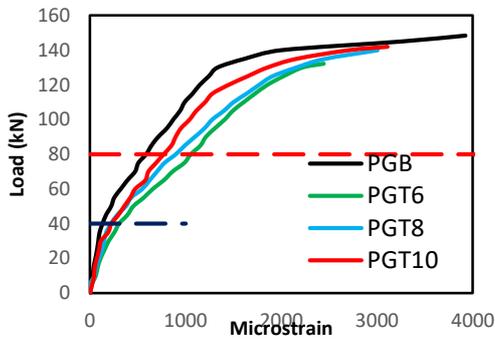
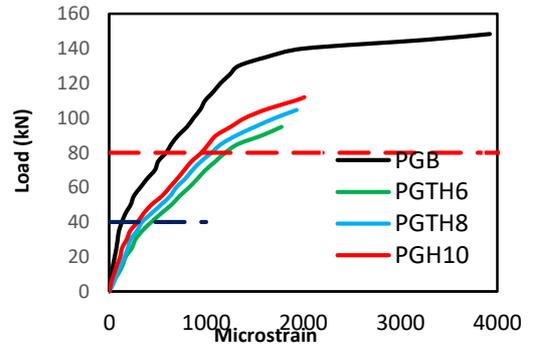
Figure 15. Load versus strain in prestressing steel of main Groups (A and B).

each rafter before the loading test, the increase in strain at ultimate loading $\Delta\varepsilon_{ps}$, the ultimate strain ε_{ps} , and the stress f_{ps} in the strand of each prestressed rafters. Figures 15 and 16 illustrate load versus strain in prestressed steel for all rafters depending on the classified groups.

For the nonperforated rafter, the stress nearby the failure stage in prestressing strands exceeded their yielding strength limit ($0.9f_{pu}$). Meanwhile, the mode of failure for these rafters was tension followed by compression failure near the load point. In contrast, the other rafters, the stresses at the failure stage in prestressing strands, did not reach the yielding stress limit ($0.9f_{pu}$).

Related to the measured strain in the prestressing strand in PGB, the highest deviation was observed in the perforated rafters of Group B when the two chords' depths decreased by 25%. This may be due to the reduction that happened in the rafter's stiffness, followed by less deviation from the rafters of Group A.

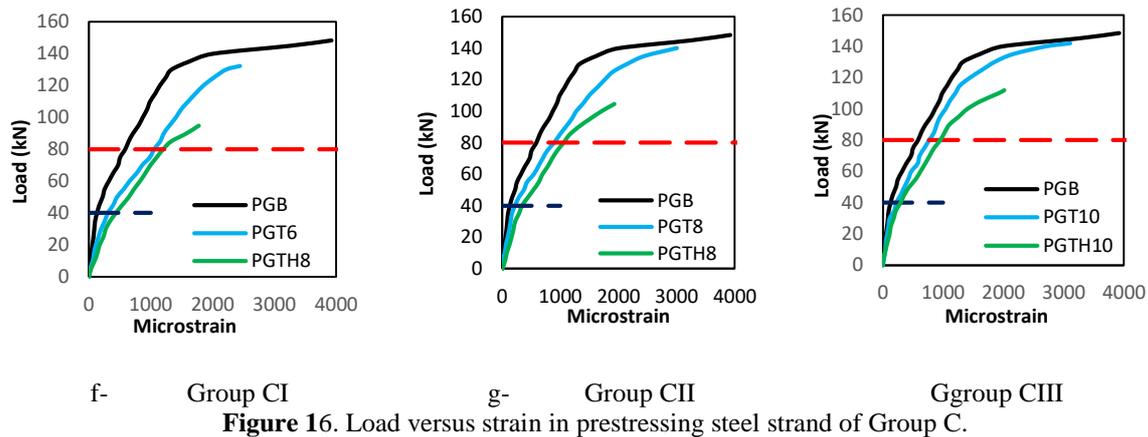
Figure 16. Load versus strain in prestressing steel strand of Group C.
