# Improvement INCOLOY Alloy 800 Weldability After 10 Years of Service Through Solution Annealing and Normalizing Method

Amir Arifin, Gunawan\* and Jaya Rizki Saputra

*Department of Mechanical Engineering, Sriwijaya University, Indralaya, Sumatera Selatan, Indonesia.*

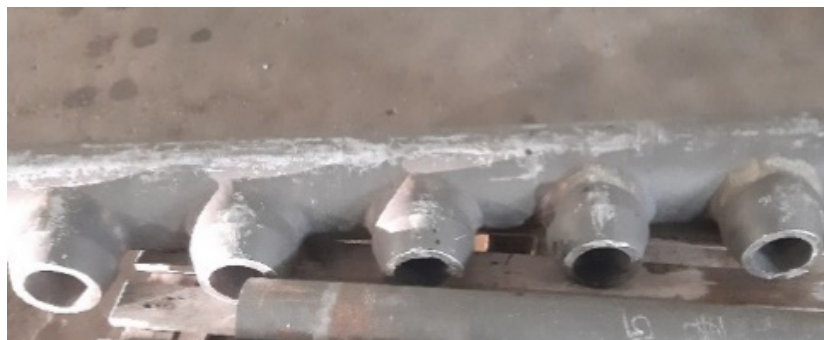
**Figure 1.** Outlet manifold bottom header.

The material used during this research process came from the outlet manifold bottom header (OMBH) component (Figure 1). The material operated at high pressures and temperatures and was categorized as a superalloy type— alloy 800—with resistance to high pressures, high temperatures and corrosion. The INCOLOY alloy 800 used by a fertilizer plant for the OMBH component produced by Manoir Industries was M900. Furthermore, the material composition was investigated through the X-ray fluorescence analyser Niton XL 2. Welding was performed using gas tungsten arc welding (GTAW) with a filler rod Er NiCrMo-3. Liquid penetrant testing was conducted before and after welding to reveal open surface welding defects. In this work, the weldability sample was measured to refer to the effect of welding on indications of defects or crack appearance after the dye penetrant test. A weldability test was performed before and after the welding process. Heat treatment for OMBH was carried out through solution annealing, and the normalizing process referred to the Association of Mechanical Engineering (ASME) standards for INCOLOY alloy 800 material. A schematic diagram for heat treatment is shown in Figure 2. The measurement of the hardness value in the weld area was carried out using the Vickers method with a diamond indenter to obtain better accuracy. The Vickers method was performed with a load of 20 kg based on the JIS Z 2244 standard with three repetitions. X-ray diffraction was conducted on the welding position to investigate phase formation. Furthermore, metallography analysis was conducted using an etching fluid (20 ml HNO<sub>3</sub> and 80 ml HCl) and optical microscope, referring to the ASTM E-407 standard.

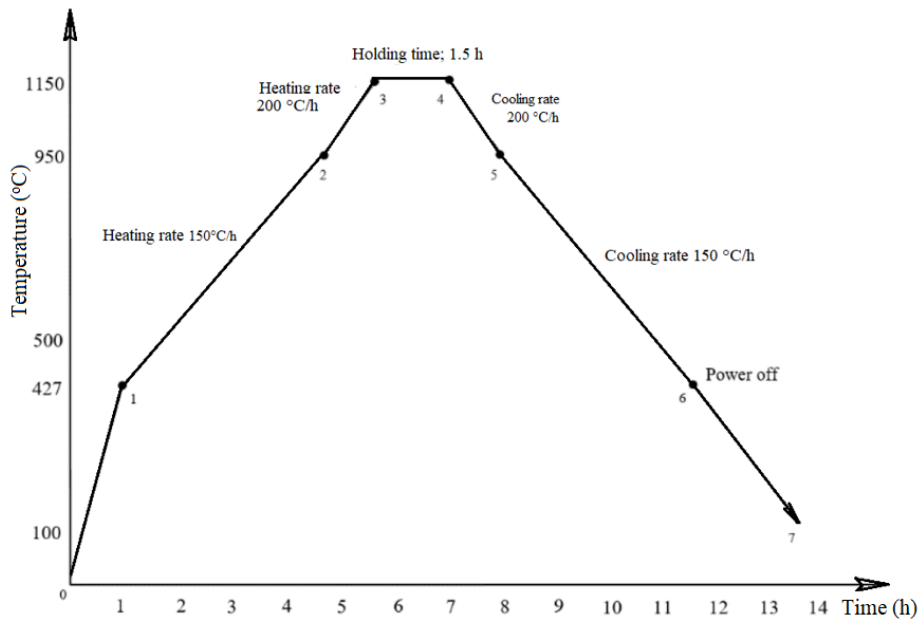
**Figure 2.** Schematic diagram of the heat treatment process: a) normalization and (b) solution annealing.

Sample heat treatment is carried out by solution annealing and normalizing methods that have the main objective of reducing residual stresses to improve the ductility of alloy 800. Parameters in heat treatment refer to ASME Section VIII Div 1 Part UCS-56 and UNF-56.

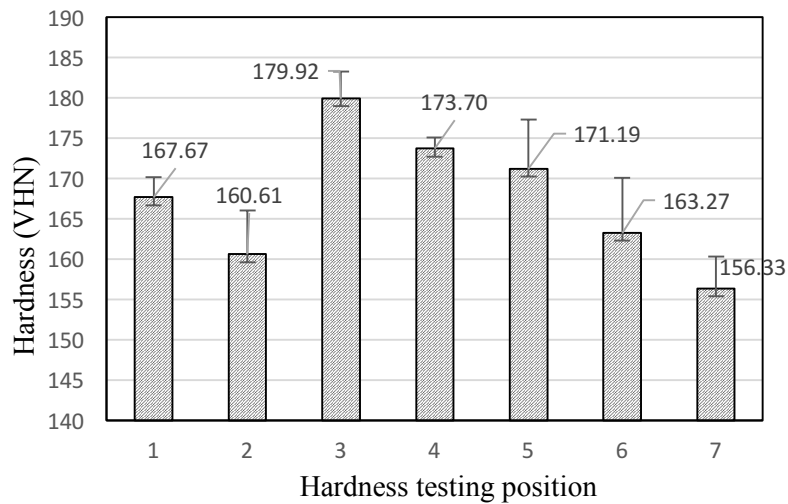
**Figure 5.** Hardness profile on the weld zone: (a) nontreatment, (b) solution annealing, and (c) normalizing.

The hardness test results shown in Figure 5 indicate that the base metal represented by zones 1, 2, 6 and 7 has decreased hardness from the technical data standard of alloy 800. The material standard technical data show that the hardness value of the superalloy material with the main element made from nickel and chromium is 170 VHN, while the highest hardness in the base metal is 167 VHN. The low hardness value of the nontreated samples is due to the prolonged exposure to heat during the operation process, as shown in Figure 5 (a). A decrease in the hardness value results in failure, such as creep. The hardness value increases in the fusion zone (zones 3,4, and 5) due to new alloys from the filler rod, as shown in Figure 5 (b).

The normalizing sample is machined and polished for preparing the hardness sample test. Furthermore, hardness testing is carried out seven times at different zones with three repetitions, as shown in Figure 4. Figure 5 (c) shows the hardness testing results for the normalized samples. The test results show that the hardness value of the base metal is close to the INCOLOY alloy 800 standard hardness value. The base metal hardness value increases after normalizing treatment relative to solution annealing and nontreated samples. Because of the slow cooling rate, the greatest hardness value on the base metal is reached at 177 VHN during the normalization process. The preservation of carbide throughout the heat treatment procedure with a slow cooling rate is significant in the resultant growth. An increase in the amount of carbide plays a role in increasing the hardness value.

The maximum hardness value is 187 VHN in zone 5 on the welding zone. Several variables, such as carbide precipitation and additional alloying elements, cause the hardness value to be high in the welding area. Figure 6 (a) shows the XRD test results from nontreatment samples. The phase characteristics of alloy 800, which has been operating for a relatively long time, consist of phases of austenite,  $\text{Cr}_{23}\text{C}_6$ , and NbC. The main peaks show the austenite phase with a  $2\theta$  value of 43.582 and a peak intensity of 768. A  $2\theta$  value of 50.1 indicates the second-highest peak phase with a peak intensity of 368 diffusions (Arifin, Gunawan, et al., 2020). The lowest peak is the diffusion of niobium and carbon, forming NbC carbides with an angle of  $2\theta$  of 74.2 and a peak intensity of 90.
